Site Inspection, Bret Clark Mine, Hub Research and Development Company, S/015/043,

Emery County, Utah

September 26, 2002

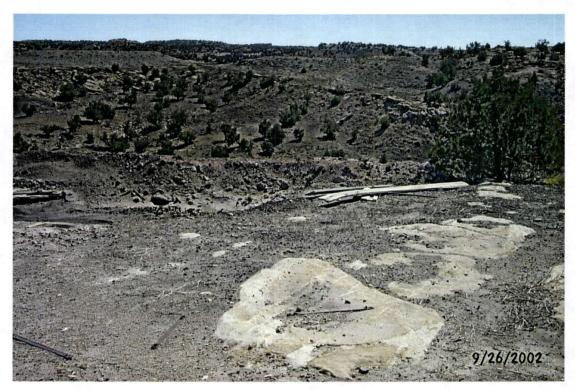
The operator has cleaned up a lot of trash and has put a berm at the top of a road at the south end of the site (Photo 1). This berm was recommended for the purpose of keeping runoff from eroding the old road and the pad outslope below. Although I think it has been helpful, there is still runoff getting to this road from other areas, and there is still some erosion (Photo 2). I understand the site had had significant precipitation in the past few weeks. There are places where the berm is breached allowing water to flow down the outslope.

Photo 1. Berm at the top of the old road. (The berm is difficult to see across the center of the photo.)

Although the breached berm allows water to flow down the outslope and erode this slope, the pad was not intended to be an impoundment. The report for the previous inspection recommended that the operator install one or more notched silt fences along the berm. This should be done in areas where the outslope is already eroded and self-armored.

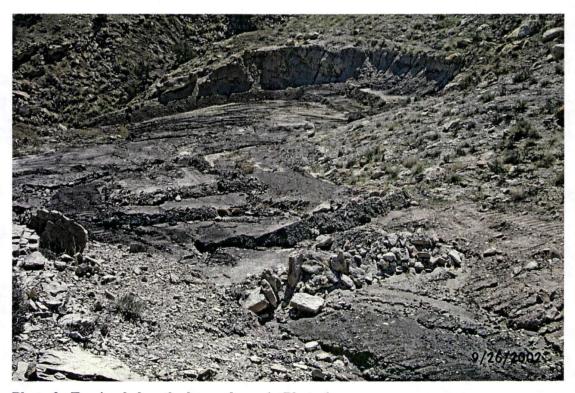
Photo 2. Erosion below the berm shown in Photo 1.

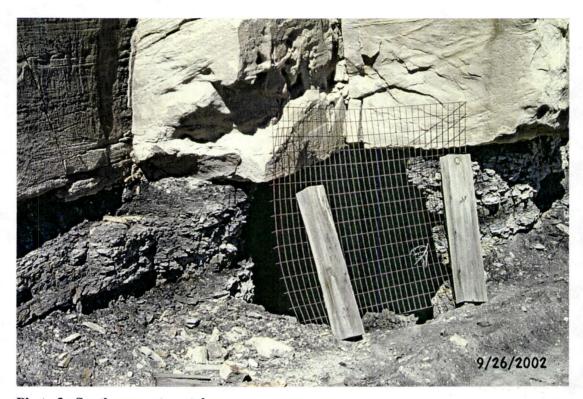
My primary concern for this site during the last inspection was that the portals were not secured. Two of the portals are still not locked. Beginning at the south end of the pad, the first portal has just a piece of fence and two timbers over the entrance (Photo 3), the same as it was during the previous inspection. The second and fourth portals had chains and locks, but the third portal was not locked (Photo 4).

Photo 3. Southernmost portal.

The open portals are not being maintained in a safe condition, so they are in violation of R647-3-112.1. It is conceivable that someone could have cut and stolen the chain and lock from the third portal, but it does not appear the operator has made any attempt to secure the first portal. The operator has twice been told to secure the portals and should receive a notice of noncompliance for not performing this work.

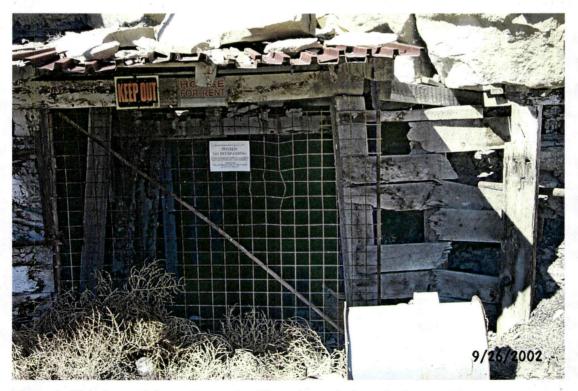
Photo 4. Third portal from the south. There is no chain or lock.
